Example 18

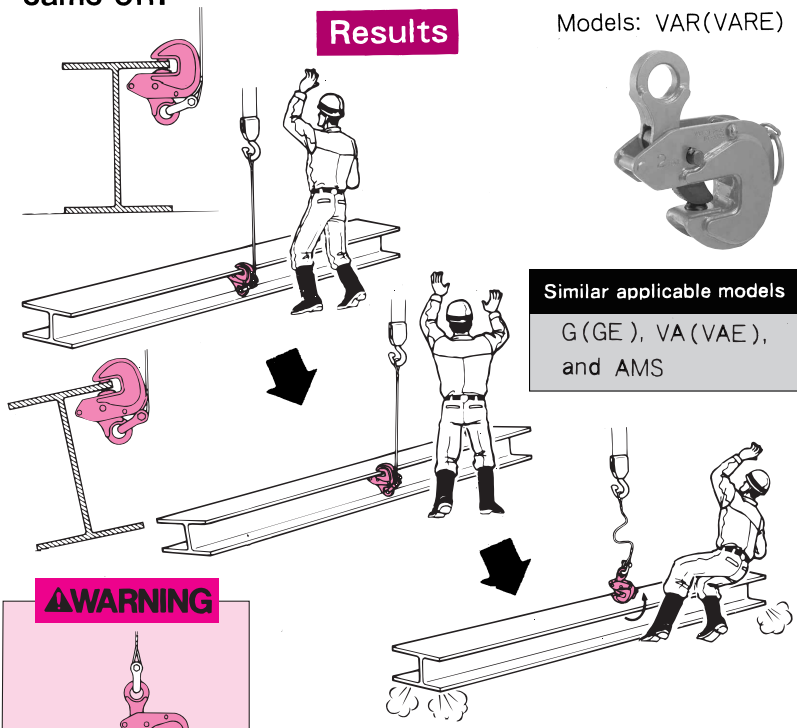
To turn over a piece of H-shape steel, the lifting shackle of the clamp was attached upside down and inserted. Because the insertion was insufficient, when the beam was lifted, the clamp came off.

Models: VAR(VARE)

Less than 5 mm

● Observe proper procedures.

- Insert completely.
- Be sure to stay clear of the swinging range of objects being lifted.

● Always use 2-point lifting.
